# Highways tree inspections for ash dieback

## Drive-by surveys

In this, our third, article we continue to share our experiences of highway tree inspections.\* This time we consider the topical issue of ash dieback surveys, again with the emphasis on putting principles into practice.

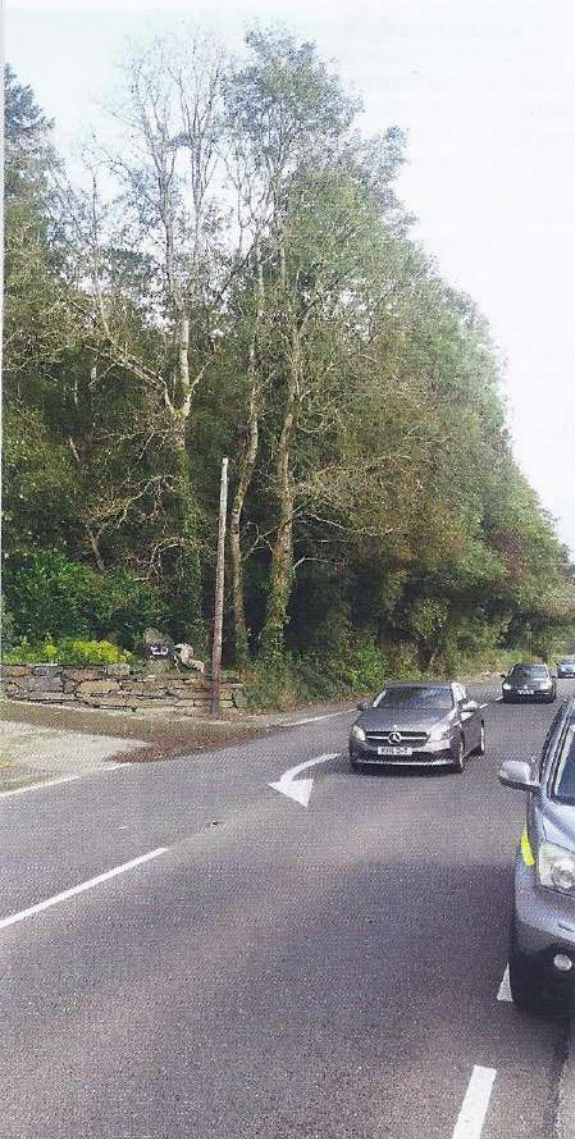
**Figure 1:** At the side of trunk road: an ash tree with noticeably reduced crown and foliage condition compared to other ash behind it.

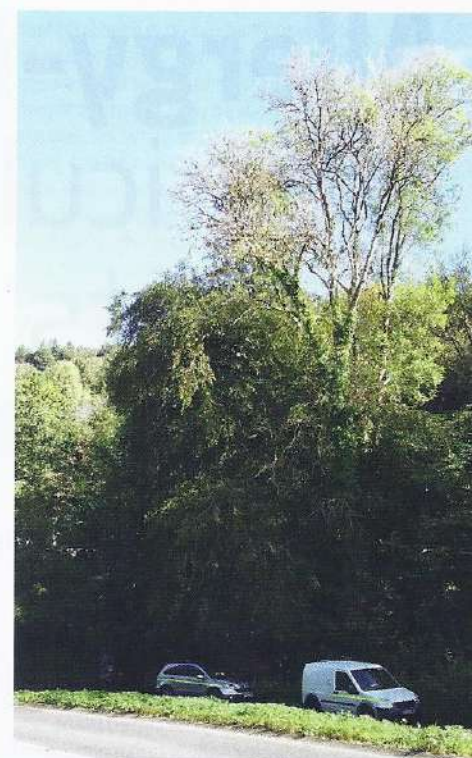
**Figure 2:** Working 'off carriageway' where it is safe to do so.

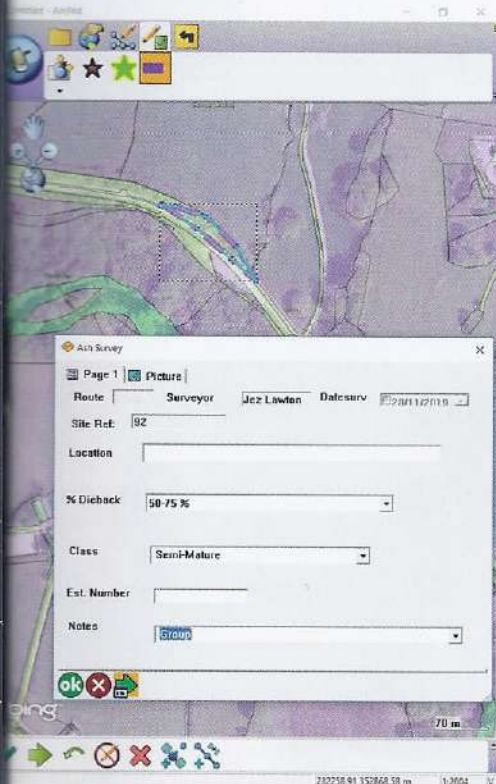
Field data collection was undertaken using ArcPad running on Windows tablets, with Bluetooth-linked GPS receivers. Our choice of ArcPad was based on experience of its ability to easily customise data collection forms and to subsequently integrate data (via shape files) with many desktop GIS applications for further analysis and presentation.

Figure 3: Field data capture form on a tablet.

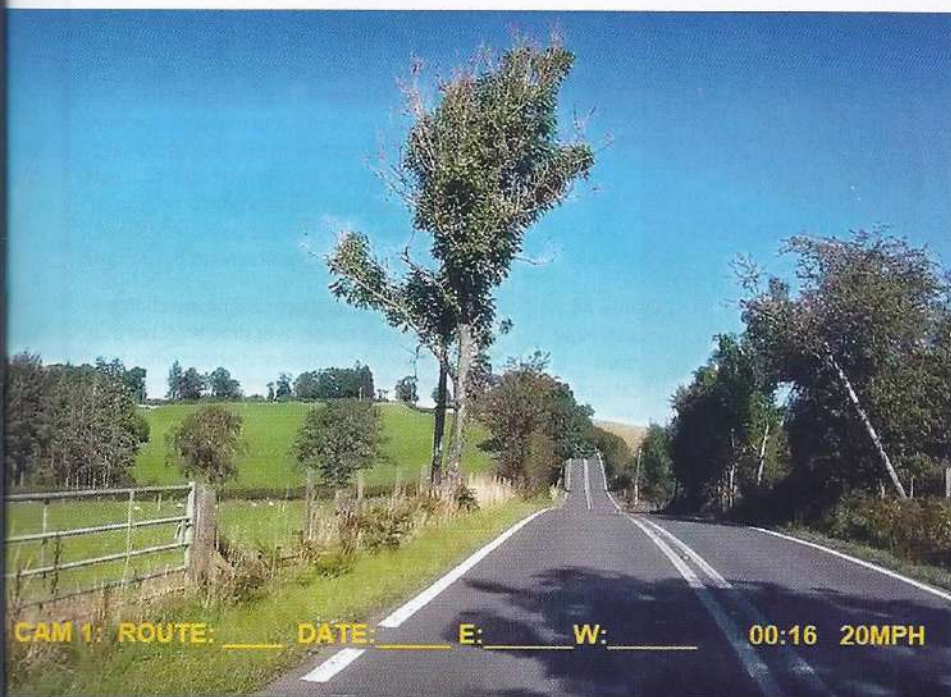
of quickly reviewing images of areas where the drive-by had taken place, thereby giving further detail of tree condition and location. Potentially, the footage could be used to monitor tree condition changes over time and inform follow-up actions. Additionally, it allows for greater initial scrutiny of areas where foot patrols cannot be safely undertaken without traffic management.

Figure 4: Vehicle video camera footage of ash trees in a narrow verge where a general foot patrol is not possible.
