# On the road

## Tree inspection and management adjacent to the Welsh trunk road network

Jez Lawton and Paolo Bavaresco

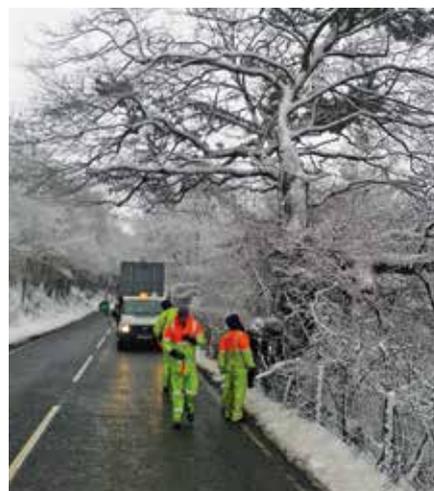
**A multi-discipline approach: working with ecology and geotechnical colleagues.**

achieved by foot patrol, with site data collected on hand-held mobile devices. In some instances we survey alongside other professionals (ecologists, geotechnical etc.) to manage resources efficiently.

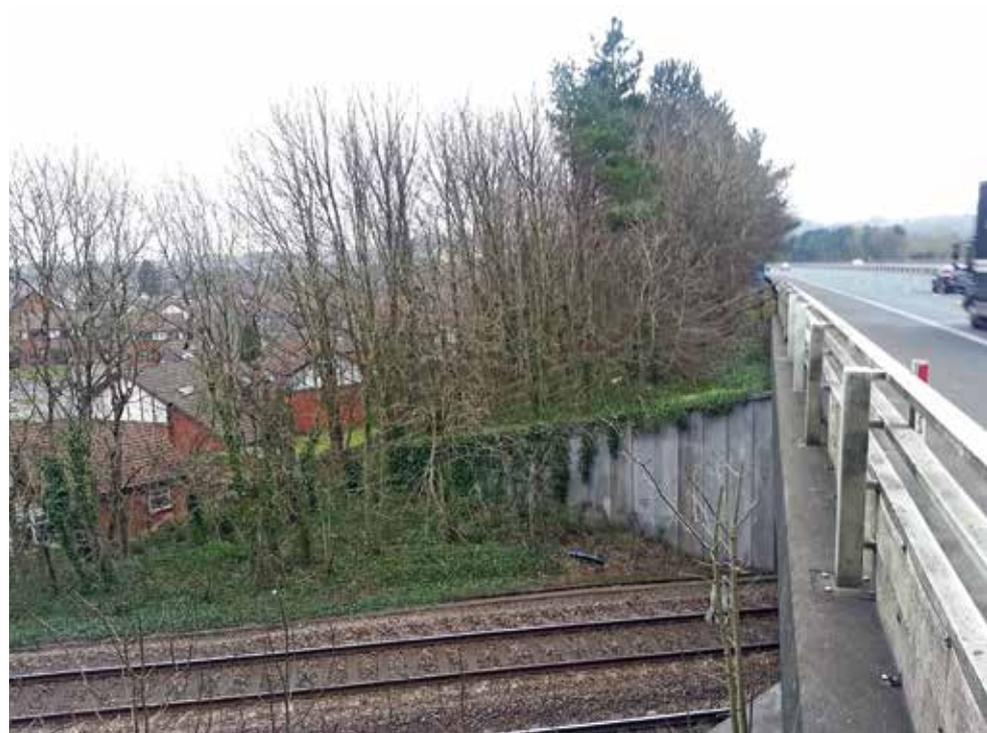
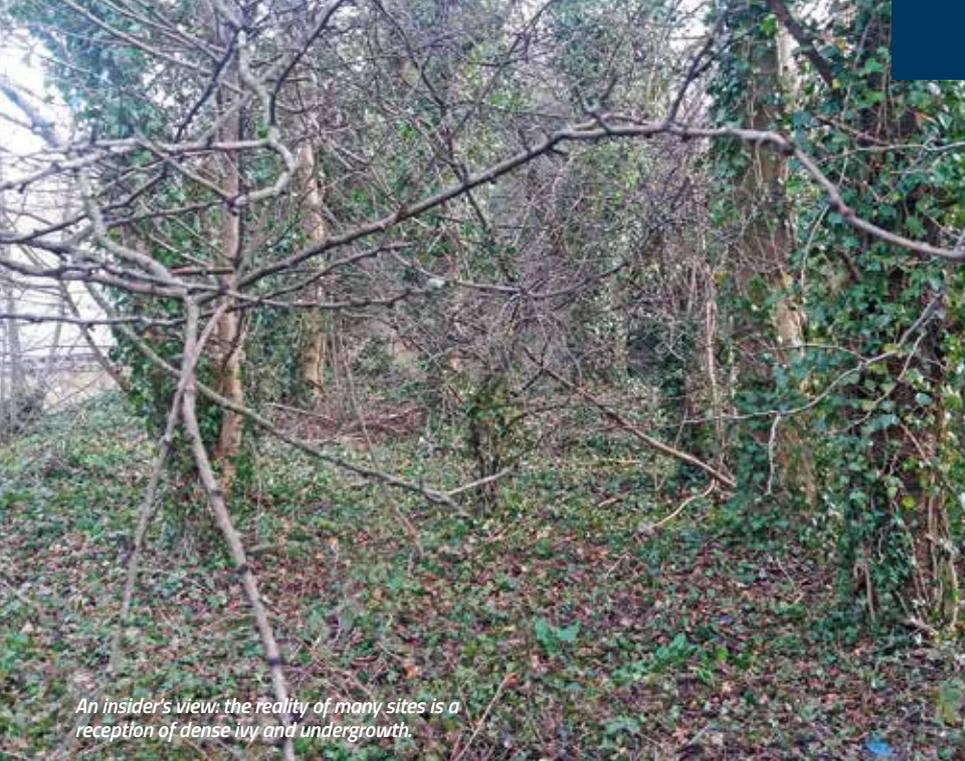
*An insider's view: the reality of many sites is a reception of dense ivy and undergrowth.*

In some circumstances the floor of tree plots can be so dense with undergrowth that venturing inside is unreasonable, impracticable and sometimes impossible. Terrain can present further restrictions through uneven, steep or otherwise impassable ground. Often, after gaining access, the trees are virtually obscured by ivy, hedging and undergrowth.

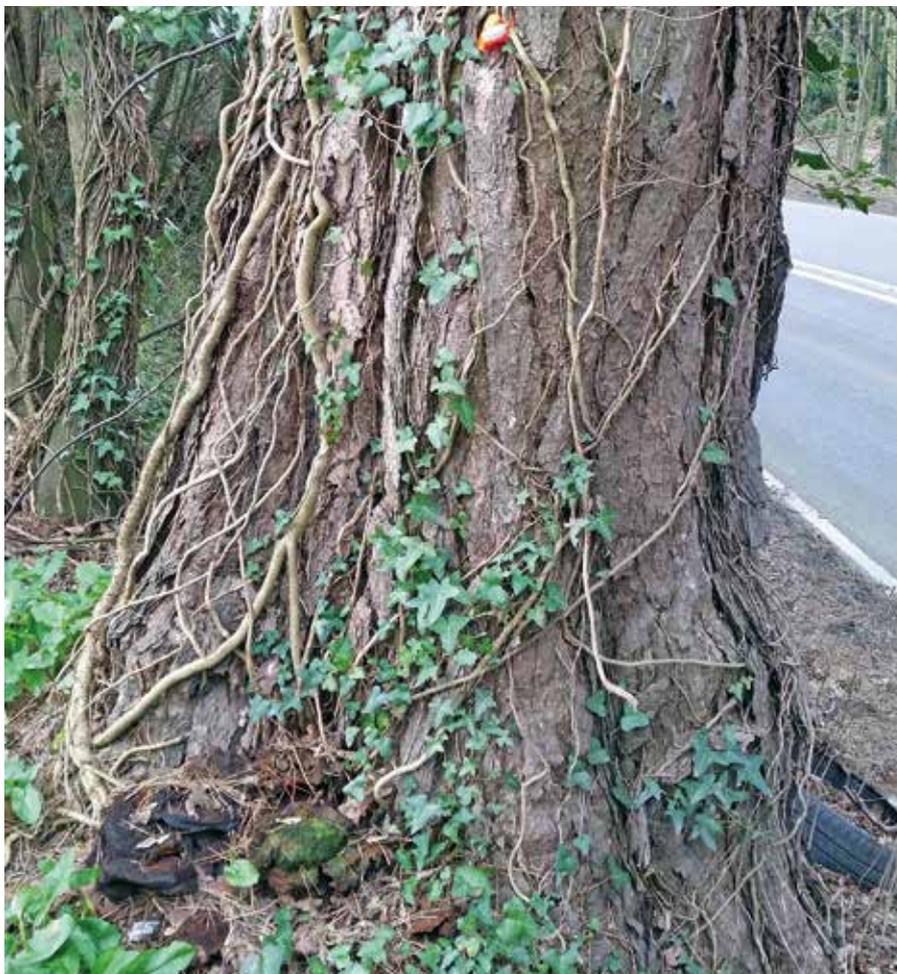
*Prominent boundary tree with basal fungus: establishing ownership is critical in ensuring appropriate and measured follow-up action.*

Issues may arise where symptoms are observed from roadside that indicate a hazard, but this (or the full implications) cannot be confirmed from the trunk road or initial inspection, e.g. the presence of fungal fruiting bodies. Obviously, the surveyor has a duty to note these findings, but when these are passed on to the tree owner there is little control over the subsequent actions taken, e.g. the competency of those providing further investigations, advice and tree work. Potentially, trees of high amenity value may either be removed or subjected to poor quality work standards.
